Manhole Inspection Summary

Manhole # S45II_036MH

Insp Date: **4/30/08 9:50 AM**

Location Address: **Federal St**

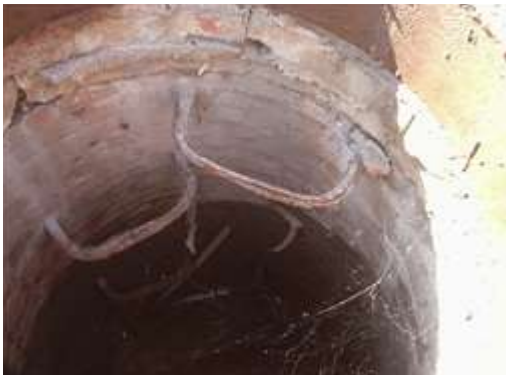
Defect 2

Condition: ☐ Sound ☐ Cracked ☐ Root Intrusion ☐ Loose Brick ☒ **Deteriorated**

Infiltration: ☐ None ☐ Joint ☐ Cracks ☒ **Mortar** ☐ Roots ☐ Wall

Deterioration

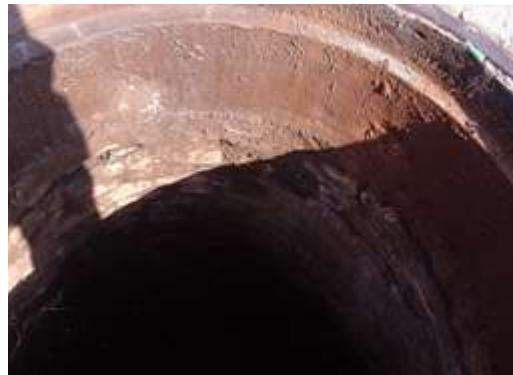
Defect 1

☒ **Leaks**

Frame Leaks

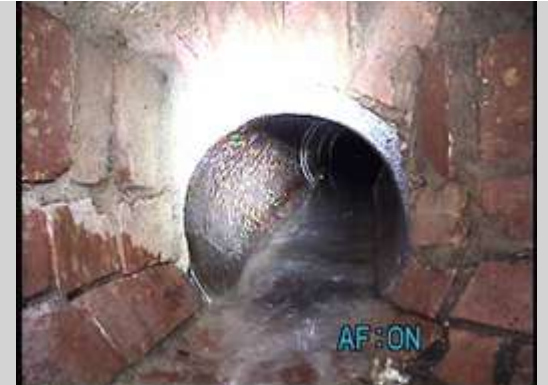
12 O'Clock Outflow

8 in. Circular Gravity Sewer
Pipe Out @ 12 O'Clock

Pipe Height: **8.4** (in.) Rod and Bar (Angled)
Pipe Material: **Clay** ☐ Pipe Lined
Invert Depth: **10.30** (ft.) Flow Characteristics: **Fast**
Deposits: ☒ None ☐ Mud ☐ Sludge ☐ Debris ☐ Grease
Silt Depth: (in.) Deposits Extent:
Infiltration: **None** Pipe Seal Cond: **Sound**

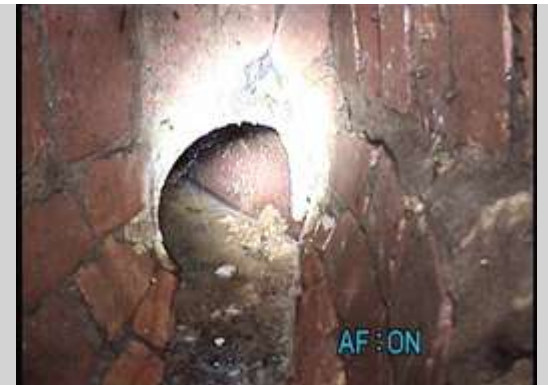
3 O'Clock Inflow

6 in. Circular Gravity Sewer
Pipe In @ 3 O'Clock

Pipe Height: **6** (in.) Rod and Bar (Angled)
Pipe Material: **Clay** ☐ Pipe Lined
Invert Depth: **10.10** (ft.) Flow Characteristics: **Slow**
Deposits: ☐ None ☒ **Mud** ☐ Sludge ☐ Debris ☐ Grease
Silt Depth: **1** (in.) Deposits Extent: **Light**
Infiltration: **None** Pipe Seal Cond: **Sound**

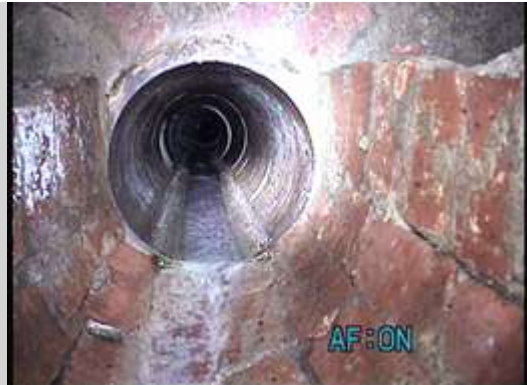
5 O'Clock Inflow

Deposits: ☒ None ☐ Mud ☐ Sludge ☐ Debris ☐ Grease

Infiltration: **None** Pipe Seal Cond: **Sound**
